ASBESTOS-CONTAINING MATERIALS SURVEY

**3M EAST SIDE PLANT
BUILDING 2
935 BUSH AVENUE
ST. PAUL, MINNESOTA**

IHSC PROJECT NUMBER M07-493

**INDUSTRIAL HYGIENE SERVICES CORPORATION
4205 White Bear Parkway, Suite 500
Vadnais Heights, Minnesota, MN 55110
(651) 766-9811**

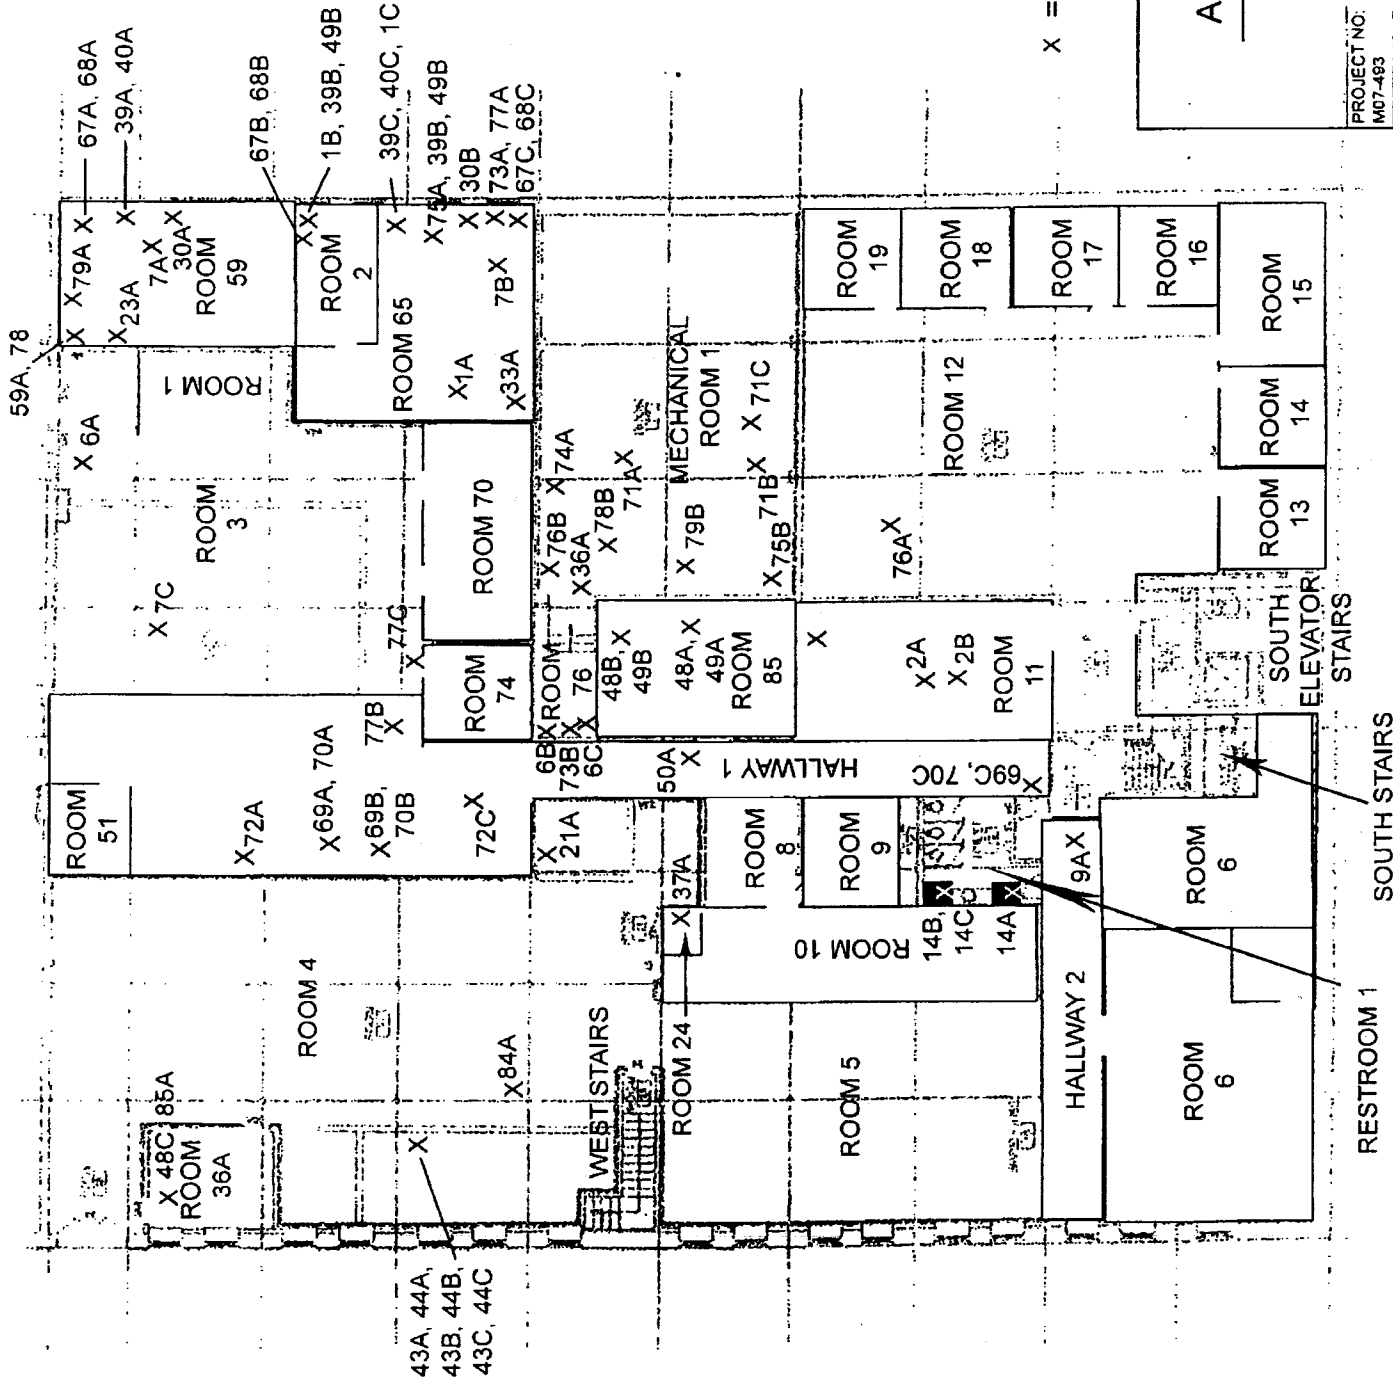
FIGURE 1
Asbestos Survey - Building 02

Basement
3M Main
Saint Paul, Minnesota

Details of the survey findings including location, material identification, physical identification, quantities and sample results are presented on the enclosed tables in Appendix A, Asbestos Material Tables. Drawings of sample locations are contained in Appendix B.
